Examination of Pump Cavitation, Gear Mesh and Blade Performance using External Vibration Characteristics

Technical Paper 249

By John S. Mitchell

Presented and published in the Proceedings of the Fourth Turbomachinery Symposium, Gas Turbine Laboratories, Texas A&M University, College Station, Texas.

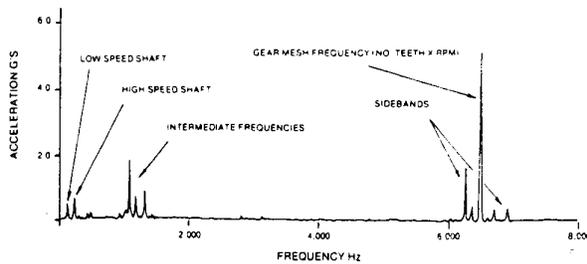
Figure 1. Vibration Signature of a Typical Industrial Double Helical Gear.

in Figure 1, a linear amplitude versus frequency spectrum plot, may be divided into three segments. First are the low frequencies containing running speeds and their harmonics up to approximately the 4th or 5th order. Next, in order of increasing frequency, is a segment beginning at the termination of the low frequencies and extending to a point in the spectrum just below the gear mesh frequency. As shown in Figure 1, a group of synchronous components are often found in this band at frequencies ranging from approximately 1,000 to 2,000 Hz. These components, hereafter designated intermediate frequencies, are likely associated with a resonance and, as will be discussed in later paragraphs, have been prime symptoms of deteriorating mechanical condition.

The final segment contains the gear mesh frequency (number of teeth multiplied by shaft speed) often surrounded by sidebands spaced at multiples of the rotational frequencies.

Although omitted from Figure 1 to enhance resolution, it is not uncommon for the gear mesh frequency to be followed by a harmonic series of its own as illustrated in Figure 2.

Likewise omitted from Figure 1 is the tooth repeat or hunting tooth frequency which may be produced when a deformed tooth or area on the gear meshes with a similarly deformed tooth or area on the pinion. The hunting frequency may be calculated from the following:

In addition to the characteristics discussed thus far, Figures 1-3 each contain spectral components in the vicinity of 1,500 Hz. Observed at varying amplitudes, roughly equivalent to the rotational frequencies, these components typically appear at multiples of the rotational frequencies between 1/3 and 1/2 of gear mesh and hence do not correlate to any obvious mechanical event. During one analysis, an order of magnitude increase was noted in the amplitudes of the intermediate frequencies compared to those recorded approximately six months earlier. Based strictly on the changes noted in the signature, a visual inspection was ordered which disclosed the damaged bearing pictured in Figure 4.

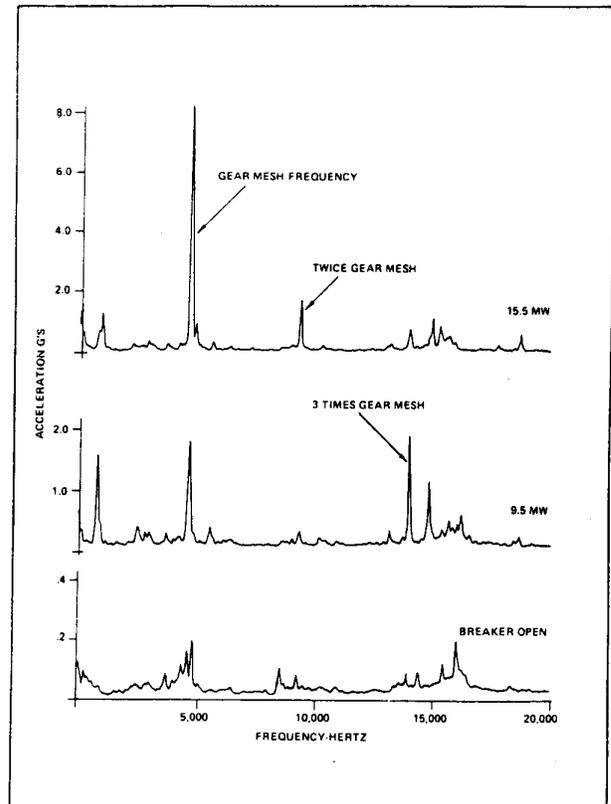
The signatures shown in Figure 2 illustrate an extreme example of load induced variations in the gear mesh frequency. Beginning with the top signature, recorded on the gear of a gas turbine generator at 15.5 MW, a significant decrease occurs as load is reduced to 9.5 MW, pictured in the middle signature.

Figure 2. High Frequency Amplitude Variations Corresponding to Changes in Gear Load.

At synchronous speed and no load the gear mesh frequency has decreased to an amplitude less than its upper sideband as shown in the bottom signature.

In addition to the likely possibility that demodulation of the gear mesh frequency will yield valuable information, the number and appearance of the harmonics of gear mesh are likewise promising as indicators of mechanical condition. Referring back to Figure 2 it can be seen that both the second and third harmonics of gear mesh vary significantly with applied load. In this particular case the relationship of harmonics to the fundamental infers a tooth engagement resembling a square wave at 9.5 MW which becomes more sinusoidal with load.

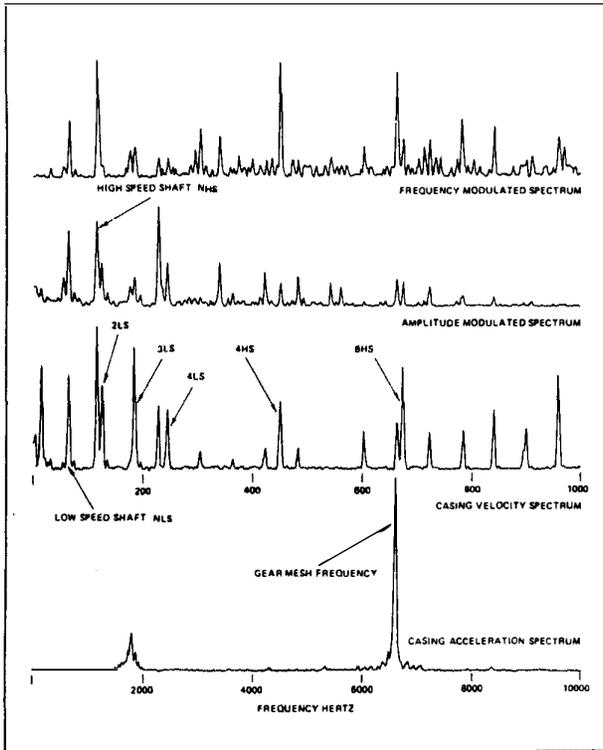
Figure 3 illustrates how demodulation can be utilized to examine gear characteristics. The lower acceleration spectrum contains the gear mesh frequency surrounded by several sidebands. Directly above, a low frequency velocity signature is pictured to show the position and relative amplitude of the rotational frequency components and their multiples. The top two signatures contain the spectral components obtained by amplitude and frequency demodulation of the gear mesh frequency and contain, as expected, the rotational frequencies as well as multiples. It is quite interesting to observe that the three most prominent components in the frequency modulated spectrum are at the high speed shaft rotational frequency and its 4th and 6th order harmonics whereas two of the three most prominent components in the amplitude modulated spectrum are at the high speed shaft rotational frequency and its 2nd order.

Figure 3. Speed Increasing Gear Casing and Demodulated Signatures.

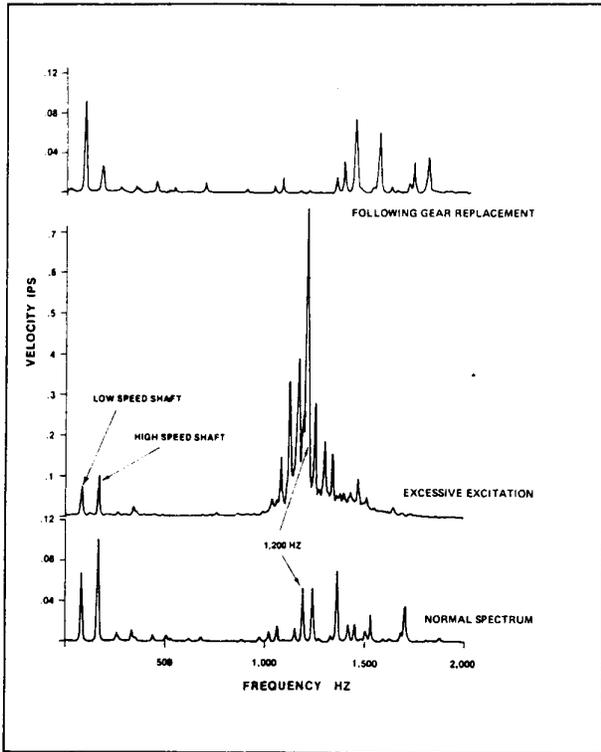
A similar incident on the second gear is illustrated in Figure 5. The normal signature shown at the bottom contains both rotational and intermediate frequencies at amplitudes which are about average for this type equipment. Although

the middle signature shows a vast increase in the intermediate frequencies, neither the rotational frequencies or the gear mesh frequency (not shown) changed by any significant degree. Recognizing a condition of extreme distress, the unit was shut down in an orderly fashion. A visual examination disclosed the heavily pitted gear elements shown in Figure 6. Surprisingly enough the journal bearings were found undamaged despite the severe excitation.

Figure 5. Speed Increasing Gear Casing Acceleration Signatures.

In an effort to learn the origin and cause of the significant increase in the intermediate frequency characteristics, both the gear and the pinion were suspended and shock excited. The results of this test indicated the 1,200 Hz center of the intermediate frequencies corresponded exactly to the fundamental resonance of the low speed gear.

By way of explanation it thus appears likely that the intermediate frequencies correspond to a resonance of one, or possibly both, gear elements. Thus a high amplitude or an increase in amplitude at the intermediate frequencies is likely to be a symptom of uneven or shock meshing which in turn excites the gear into vibration at its fundamental natural frequency.

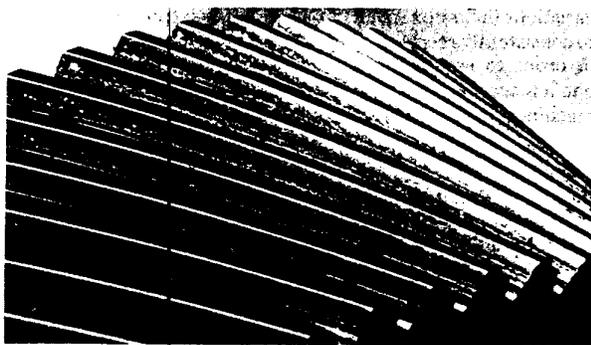
Figure 6. Pitted Low Speed Gear Removed From an Industrial Speed Increaser.

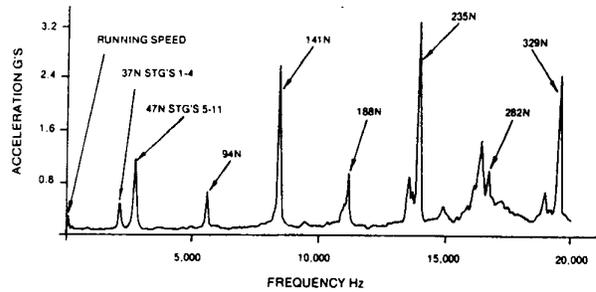
The vibration signatures recorded on axial flow compressors and gas turbines always contain prominent components at blade passing frequencies (number of blades times rotational frequency) as shown in Figures 7 and 8.

Figure 7. Axial Flow Compressor Casing Acceleration Signature.

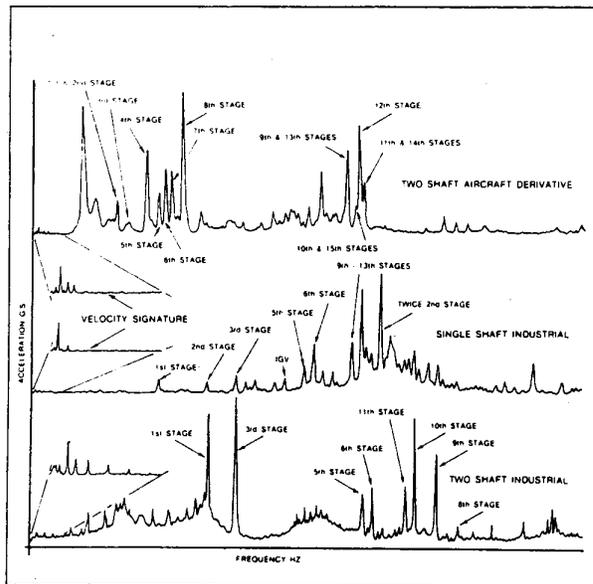
Figure 8. Gas Turbine Casing Acceleration Signatures — Axial Compressor Section.

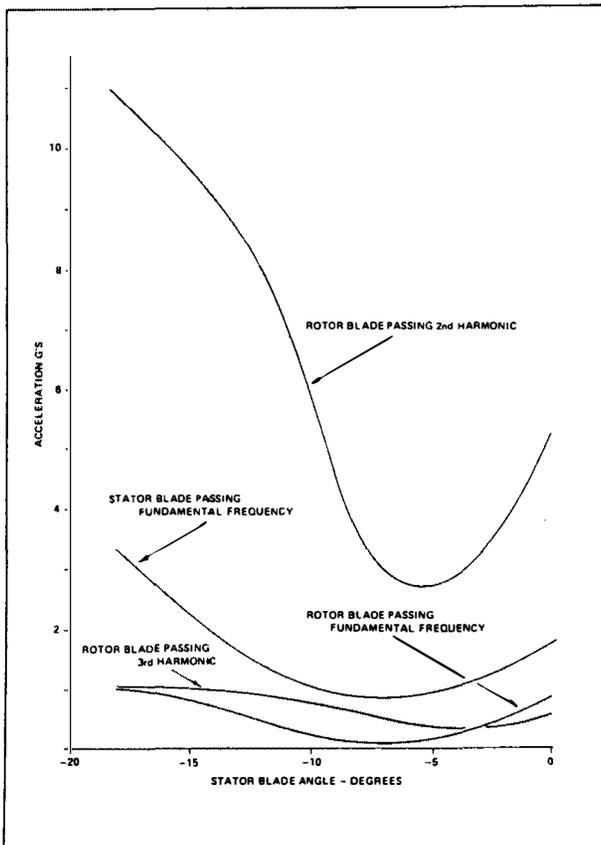
A second curiosity noted during studies of axial flow compressors is the amplitude variation at blade passing frequencies in response to speed, pressure ratio and angle of stator blading. Figure 9 illustrates a typical response at various stator blade angles with speed and pressure ratio held constant. Note that the highest amplitude, which in this case corresponds to twice

Figure 9. Amplitude Variations at Blade Passing Frequency and Multiples as a Function of Stator Blade Position.

the rotor blade passing frequency, occurs with the stator blades in the maximum closed position (large negative angles). As the stators open all the amplitudes decrease, particularly the previously mentioned twice rotor blade passing until a minimum point is reached. Following the point of minimum excitation opening the blades further produces a corresponding increase in amplitude.

The significance of the above response may be in the ability to detect blade anomalies such as damage or an incorrect angle once the normal characteristics of a given machine are known. To test this theory a gas turbine, known to have blade damage in the first stage turbine, was located, recorded and the sonic vibration signatures compared against a group of signatures recorded at the same location on similar units. Interestingly enough there was no measurable difference. This observation was quite puzzling until it was realized that the turbine had been derated to keep exhaust temperature within safe limits and the data was being compared against blade characteristics recorded at a significantly higher power level. Based on the earlier study with axial flow compressors it seemed reasonable to assume that a decreased mass flow through the turbine at the lower power should have produced a corresponding reduction in the amplitude at the first stage blade passing frequency. Hence, although the blade characteristics appeared normal compared to amplitudes recorded at a higher power they might be clearly abnormal when compared to characteristics recorded from a turbine in satisfactory condition at the lower power level.

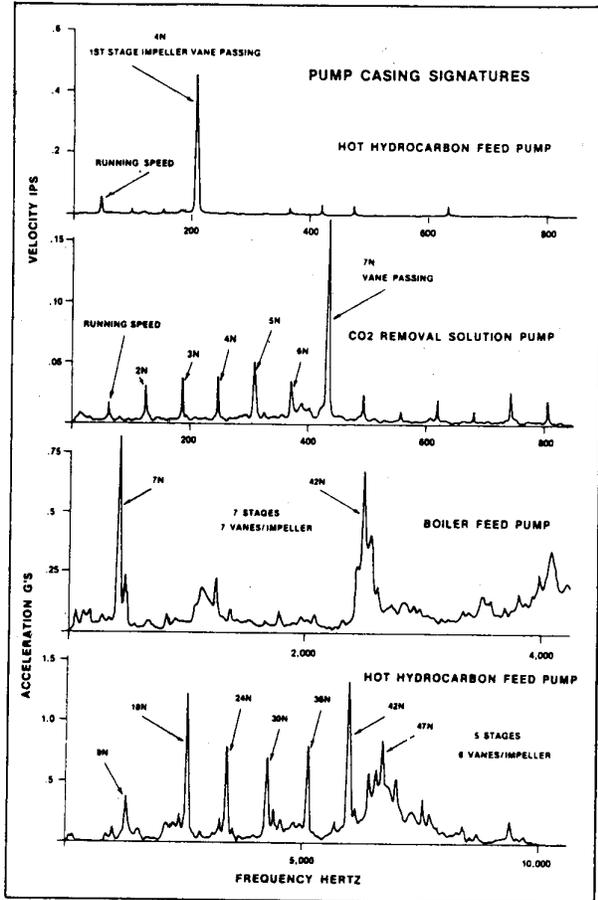
Figure 10 illustrates the prominent vane passing frequencies recorded on a group of centrifugal pumps. Within this group the CO₂ Solution Pump was confirmed by calculations

to be operating with insufficient suction head and in fact had experienced mechanical difficulties for years. The presence of numerous multiples of running frequency in addition to vane passing frequency indicates the pump was in a deteriorated condition when the signature was recorded.

Figure 10. Pump Casing Signatures Displaying Prominent Components at Impeller Vane Passing Frequencies.

Since the signatures recorded in Figure 10 were all obtained during the course of field problems more work needs to be accomplished under controlled conditions to establish the exact relationship between amplitude at vane passing frequency and cavitation.

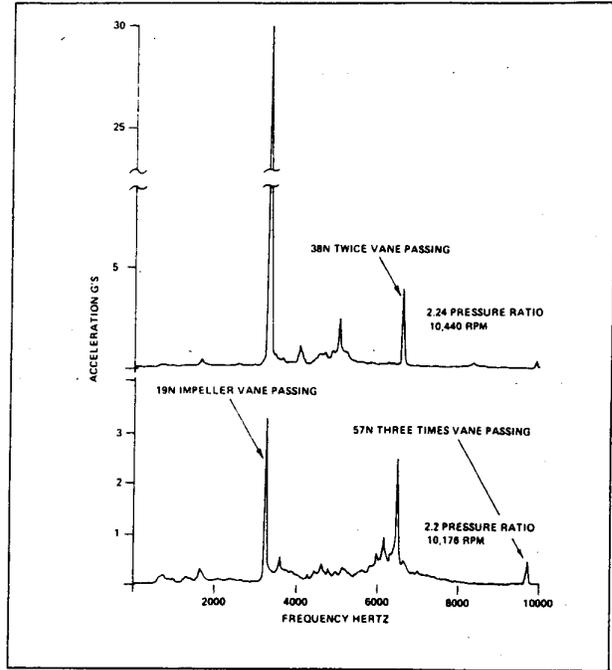
Figure 11 illustrates the response of the impeller vane passing frequency recorded on a centrifugal compressor as speed and pressure ratio were increased to move the operating point closer to surge. Although such a large change is probably an exception rather than the rule it seems logical to assume that measurable variations in vibration will occur in response to changing flow patterns within the machine.

Figure 11. Amplitude Variation of a Centrifugal Compressor Vane Passing Frequency in Response to a Change in Speed and Pressure Ratio.

As an explanation for these observations, it appears likely that approaching a condition such as surge or cavitation increases the turbulence through the impeller passages which in turn appears externally as an increased amplitude at vane passing frequency. While knowledge of this response can be quite beneficial when applied to diagnostics it may be much more valuable incorporated into a monitoring system installed on a critical high head unit where a condition such as surge
